Yakutat Airport - Long-Term Alternate Water Feasibility Study

YAKUTAT, ALASKA

Subject: FINAL REPORT, YAKUTAT AIRPORT - LONG-TERM
ALTERNATE WATER FEASIBILITY STUDY, YAKUTAT, ALASKA

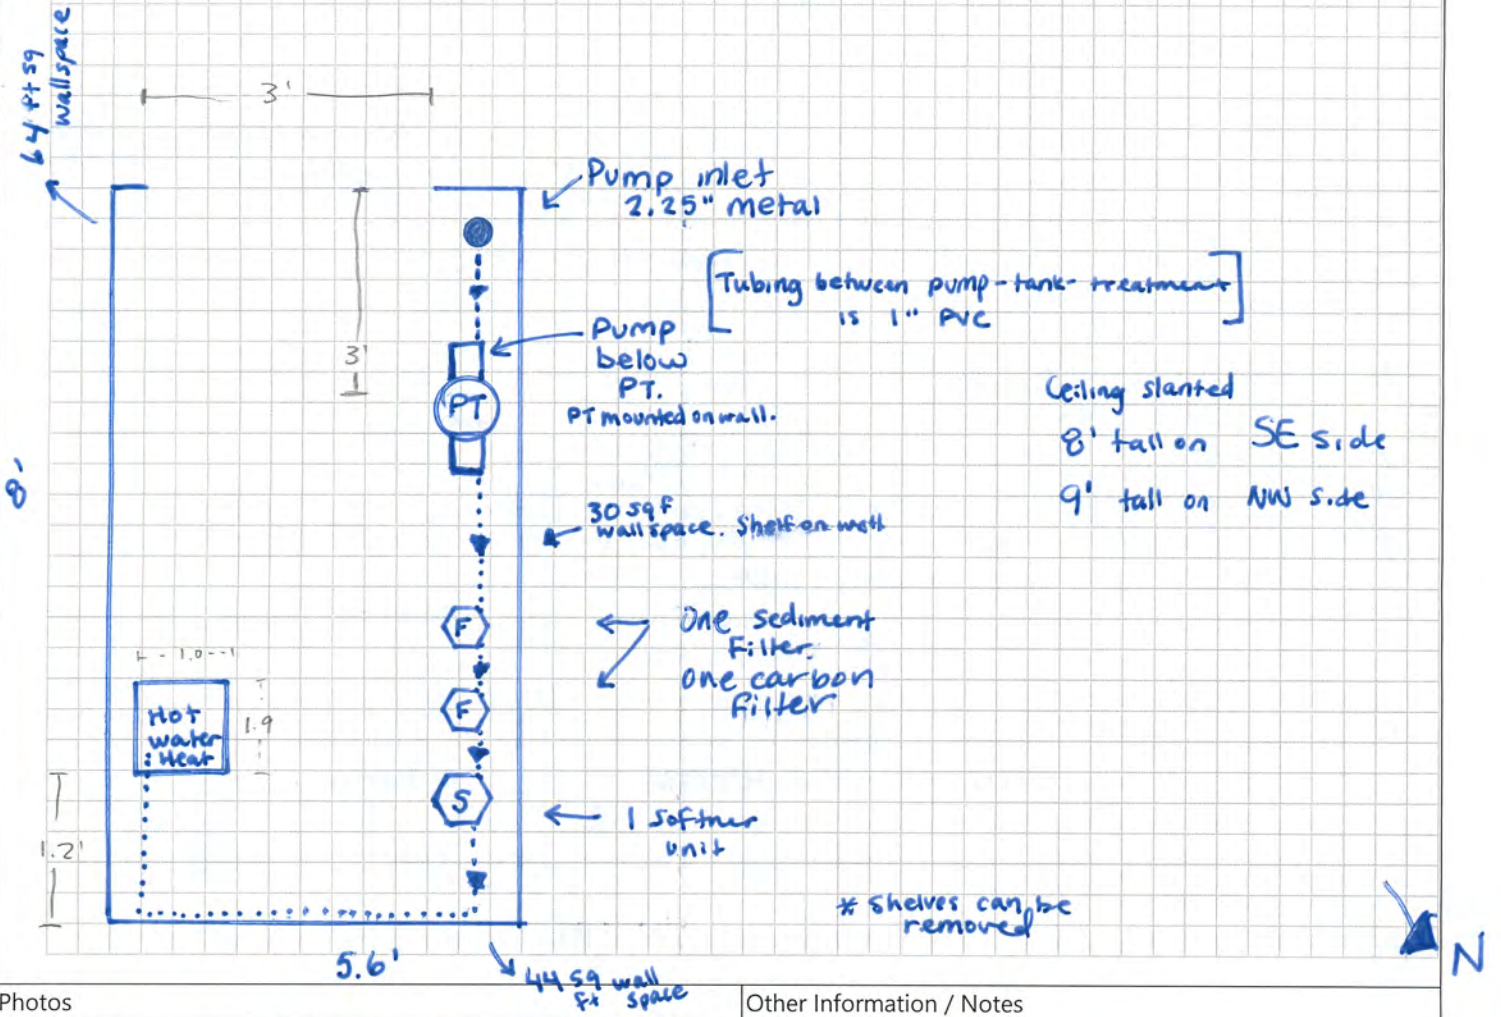
Sketches Indoor

S = Softener
 F = Filter
 PT = Pressure Tank

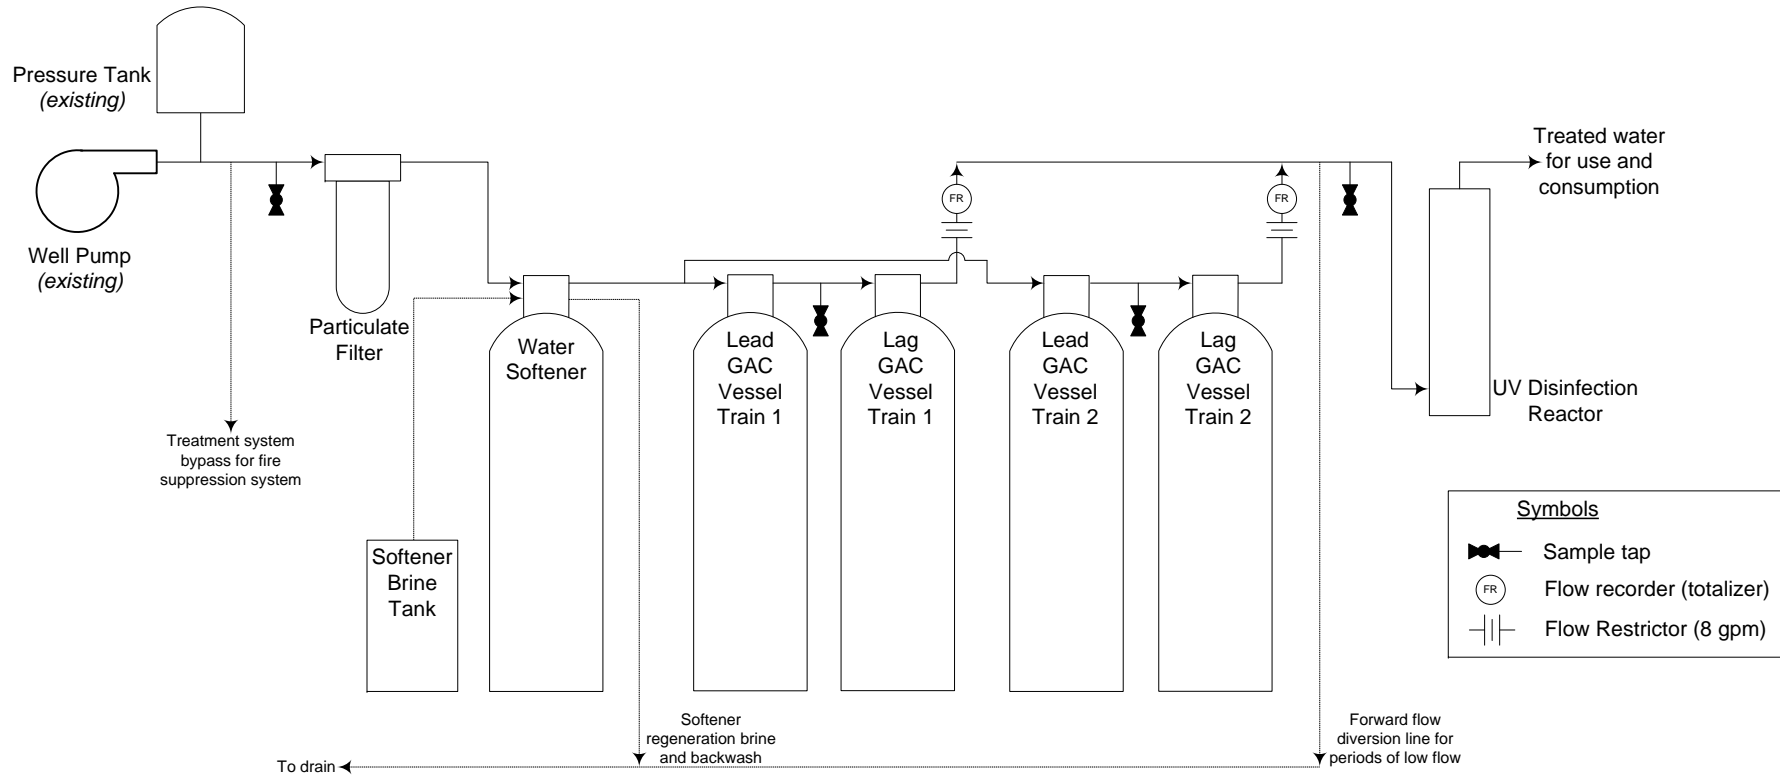
GAC Media
Prominent Systems
Filter Media
PS-CL1240AW
Coal-based, 12x40 Mesh

UV Disinfection Reactor
UV Max Pro20
(31"x4"; 316L SST)
20 gpm max forward flow
10-100 PSI operating pressure

Symbols

- Sample tap
- Flow recorder (totalizer)
- Flow Restrictor (8 gpm)
