Department of Transportation and Public Facilities

Re: Copper River Highway Planning and Environmental Linkage Study

Due to the unique environmental setting of the study area and the complex challenges associated with the necessary repairs throughout this corridor (MP 27 through MP 51), the DOT&PF is using a Planning and Environmental Linkage (PEL) study to advance the planning analyses, which can later be adopted or cited by reference into the National Environmental Policy Act (NEPA) document.

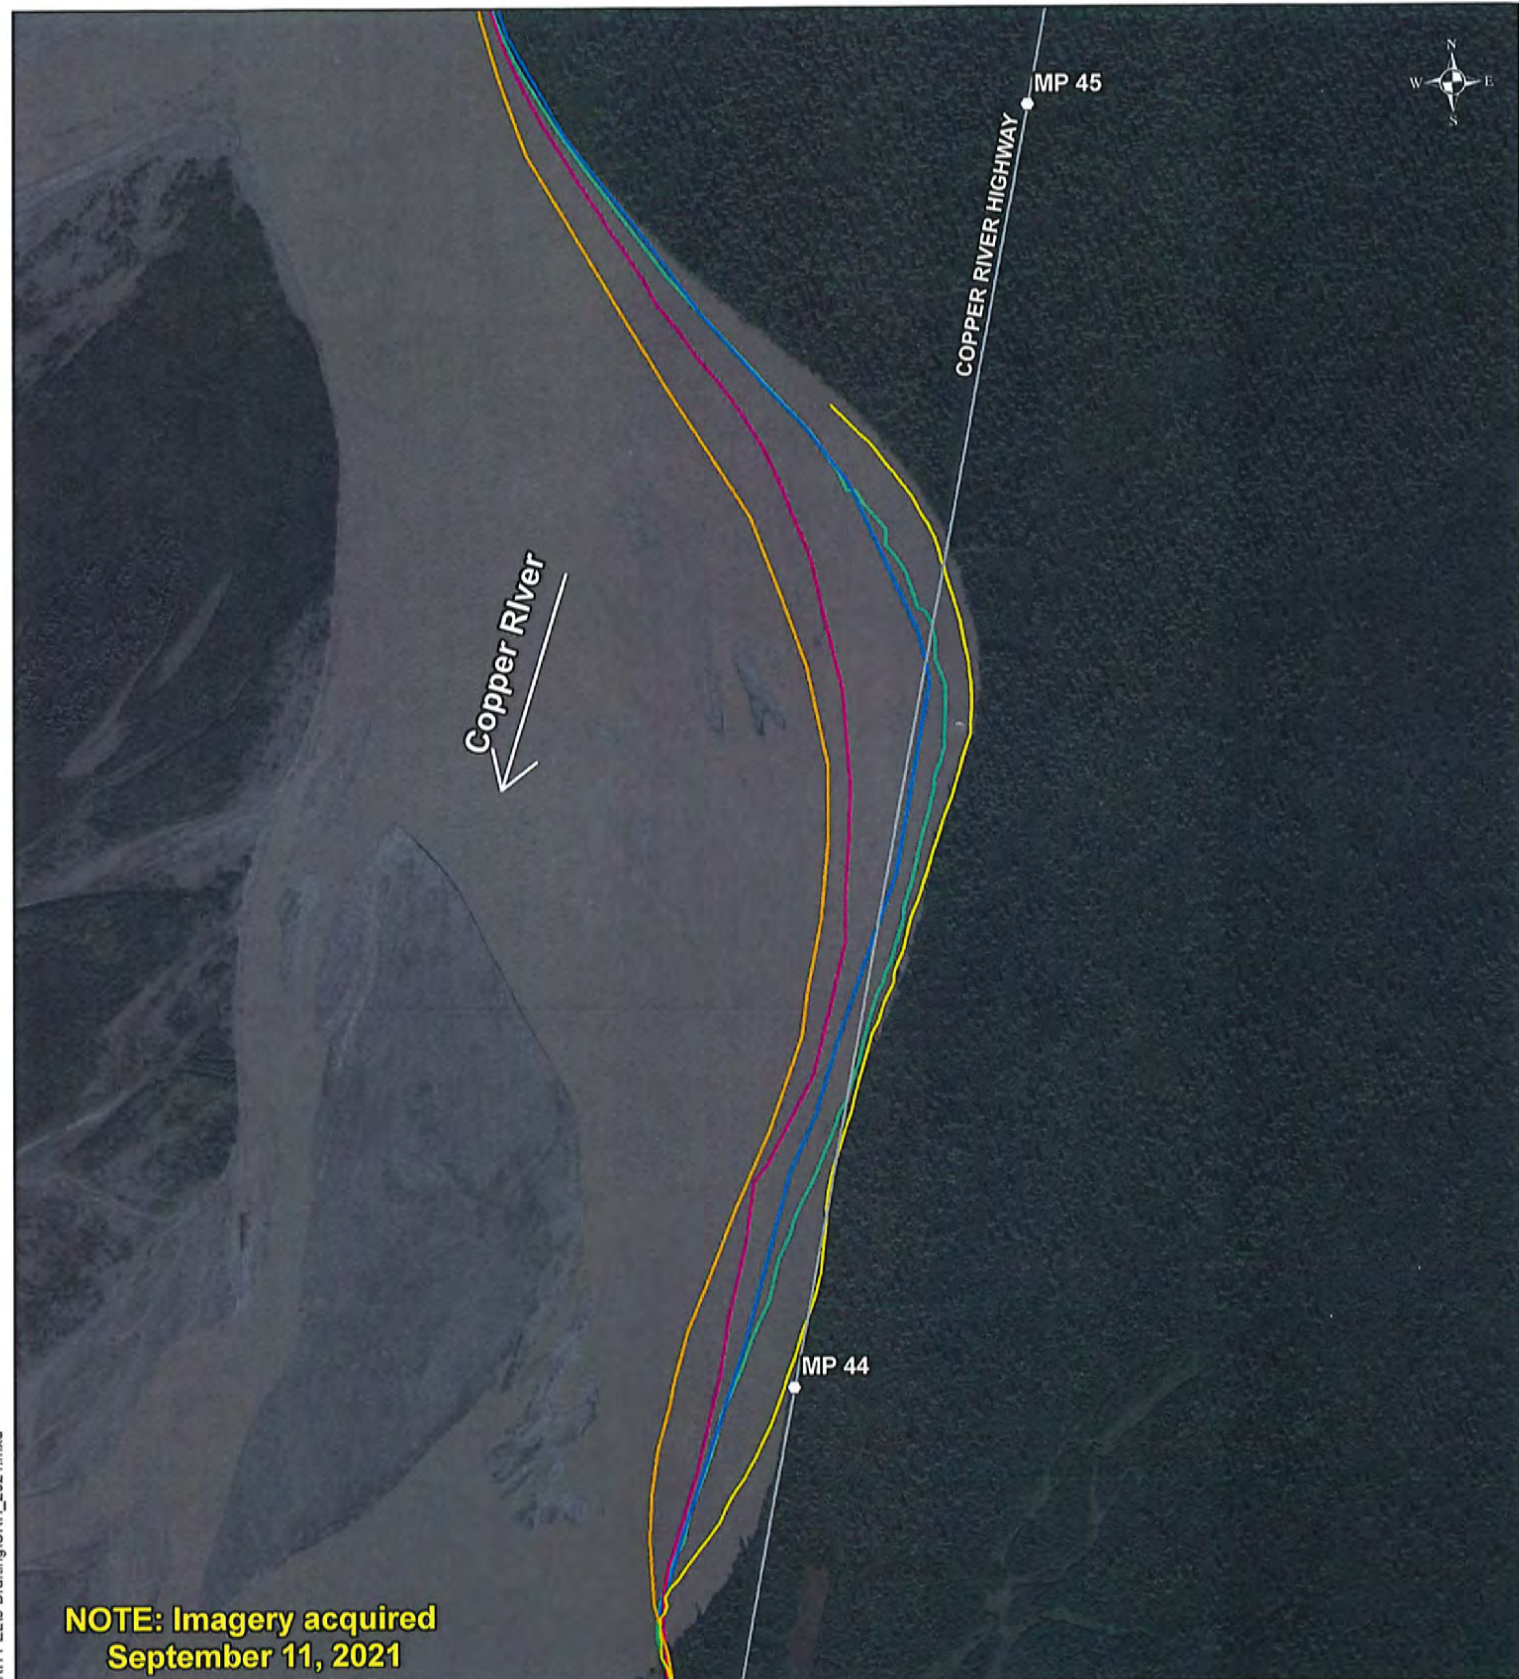
FIGURE 2

Figure 2: Chronology of Channel Migration Near MP 44, Copper River Highway

NOTE: Imagery acquired September 11, 2021

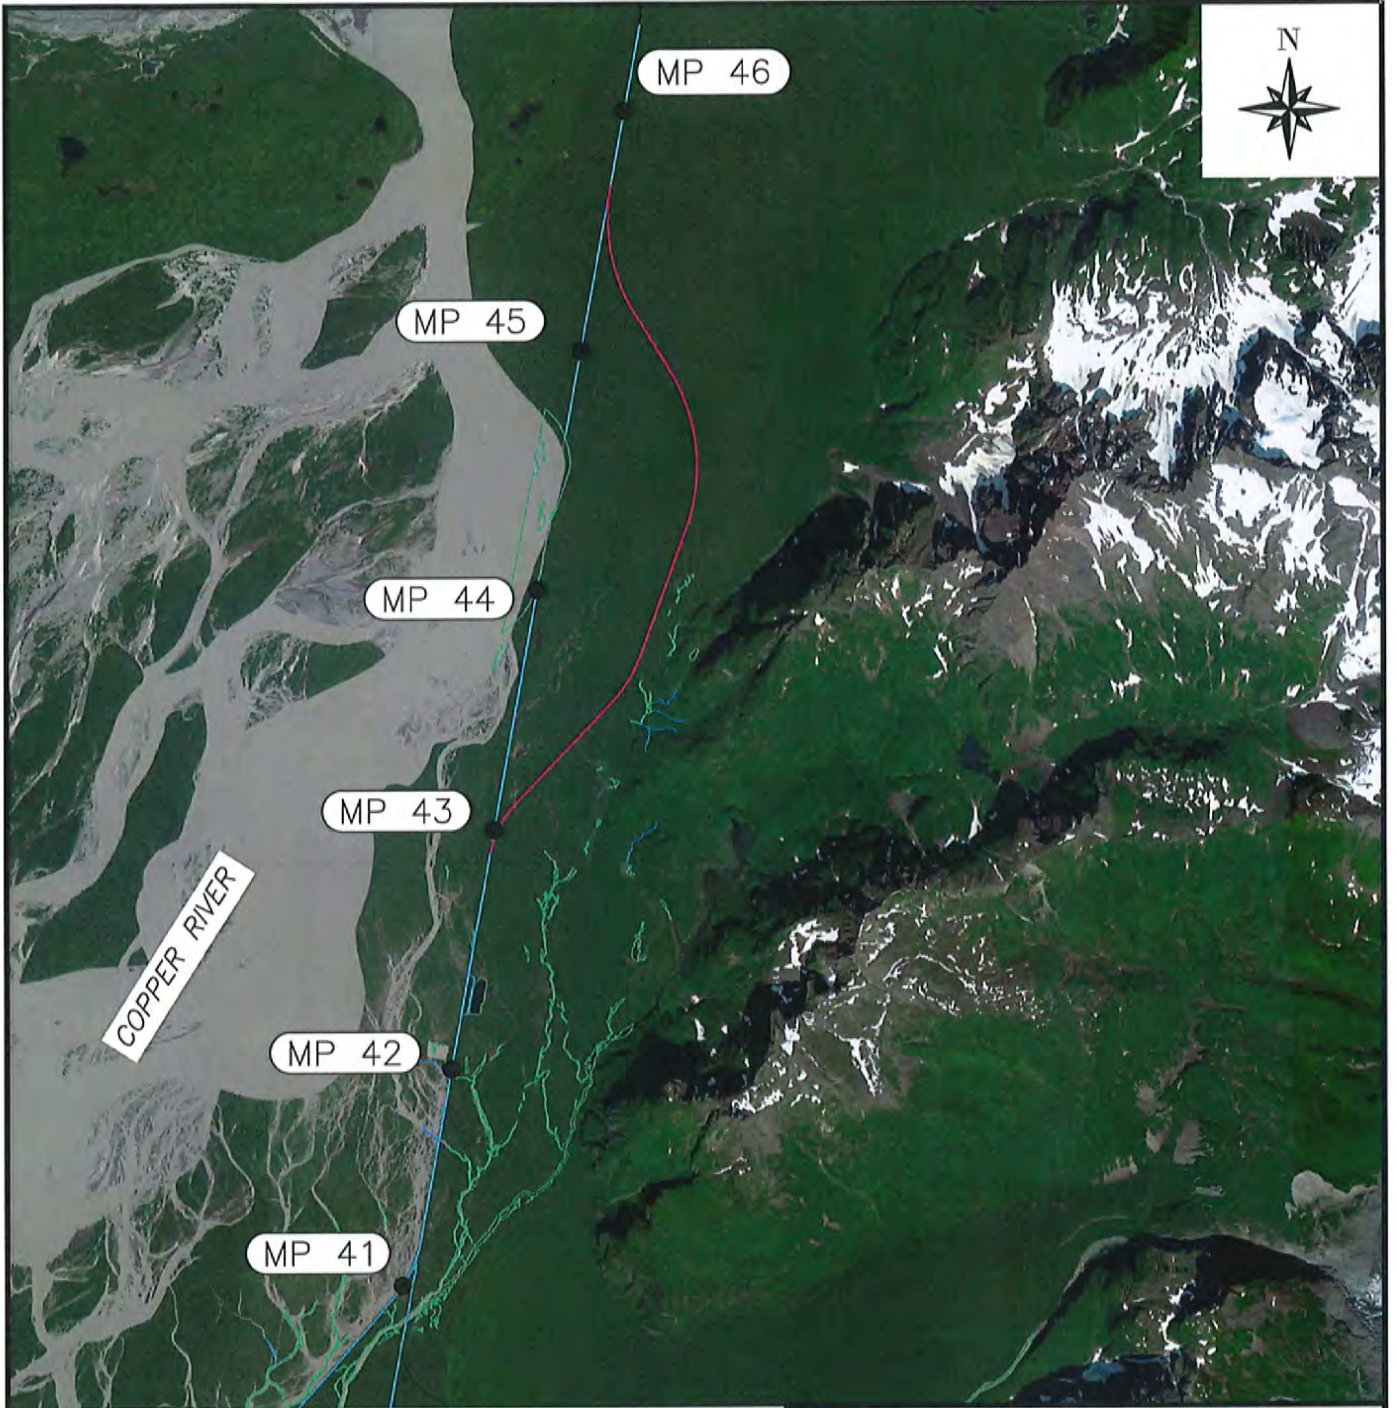
FIGURE 3

Figure 3: Proposed Realignment Around MP 44 Washout, Copper River Highway

- COPPER RIVER HIGHWAY
- PROPOSED REALIGNMENT

Under this alternative a new segment of roadway is proposed to be constructed around the washout between MP 44 and MP 45 and around the area threatened by erosion between MP 43.5 and MP 44. The new alignment would start just before MP 43 and gently curve eastward toward the toe of the mountains, it would then curve back westward and tie back into the existing CRH past MP 45, a distance of approximately 3.1 miles (Figure 3). This proposed alignment would be constructed on land owned by TEC, therefore ROW acquisition would be required.

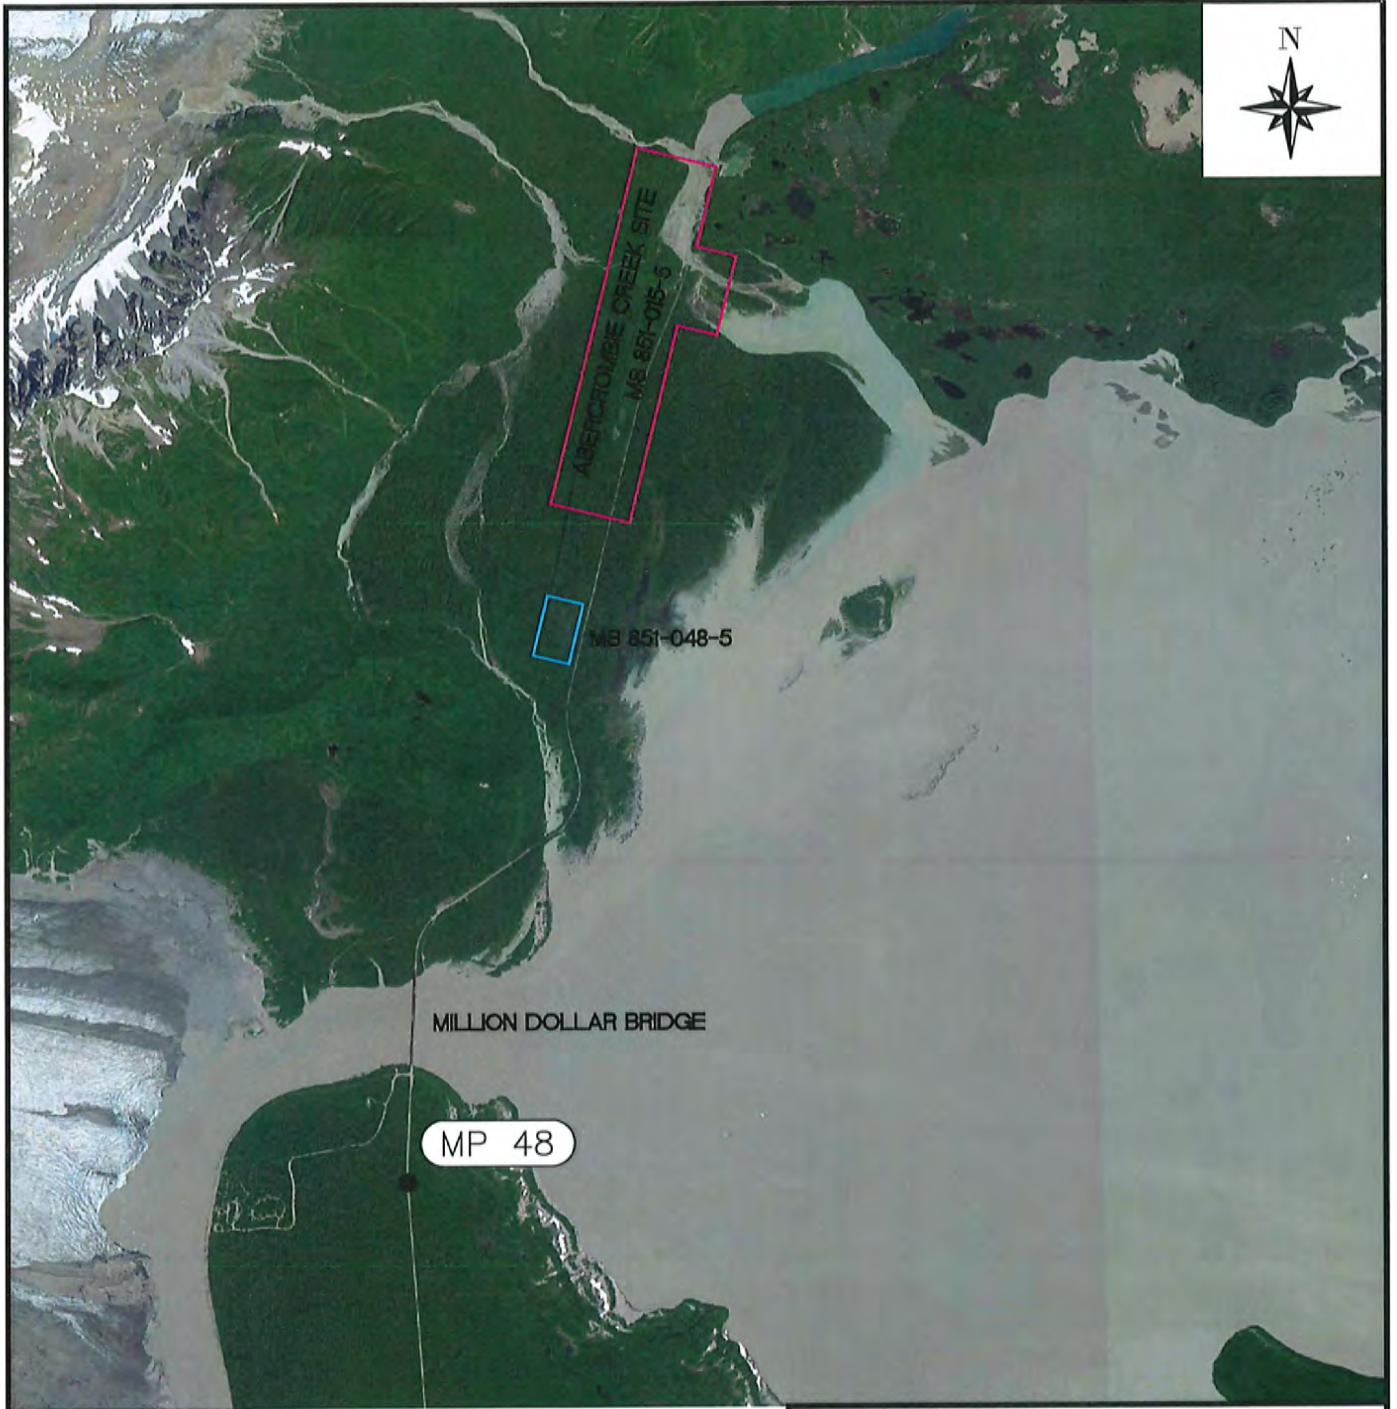
FIGURE 4

Figure 4: Locations of Proposed Material Sites North of the Million Dollar Bridge

- PRIMARY MATERIAL SITE
- ALTERNATE MATERIAL SITE

The material site with the most potential is named 851-015-5, it is located north of the Million Dollar Bridge between approximate MP 50 through MP 51 and within Section 5, Township 14 South, Range 4 East, Copper River Meridian, USGS Quad map Cordova C-2. The north end of this site encompasses a portion of Abercrombie Creek, an anadromous stream (AWC 212-20-10080-2055) identified as rearing habitat for chinook, sockeye, and coho salmon. The enclosed Figure 4 depicts the location of material site 851-015-5.

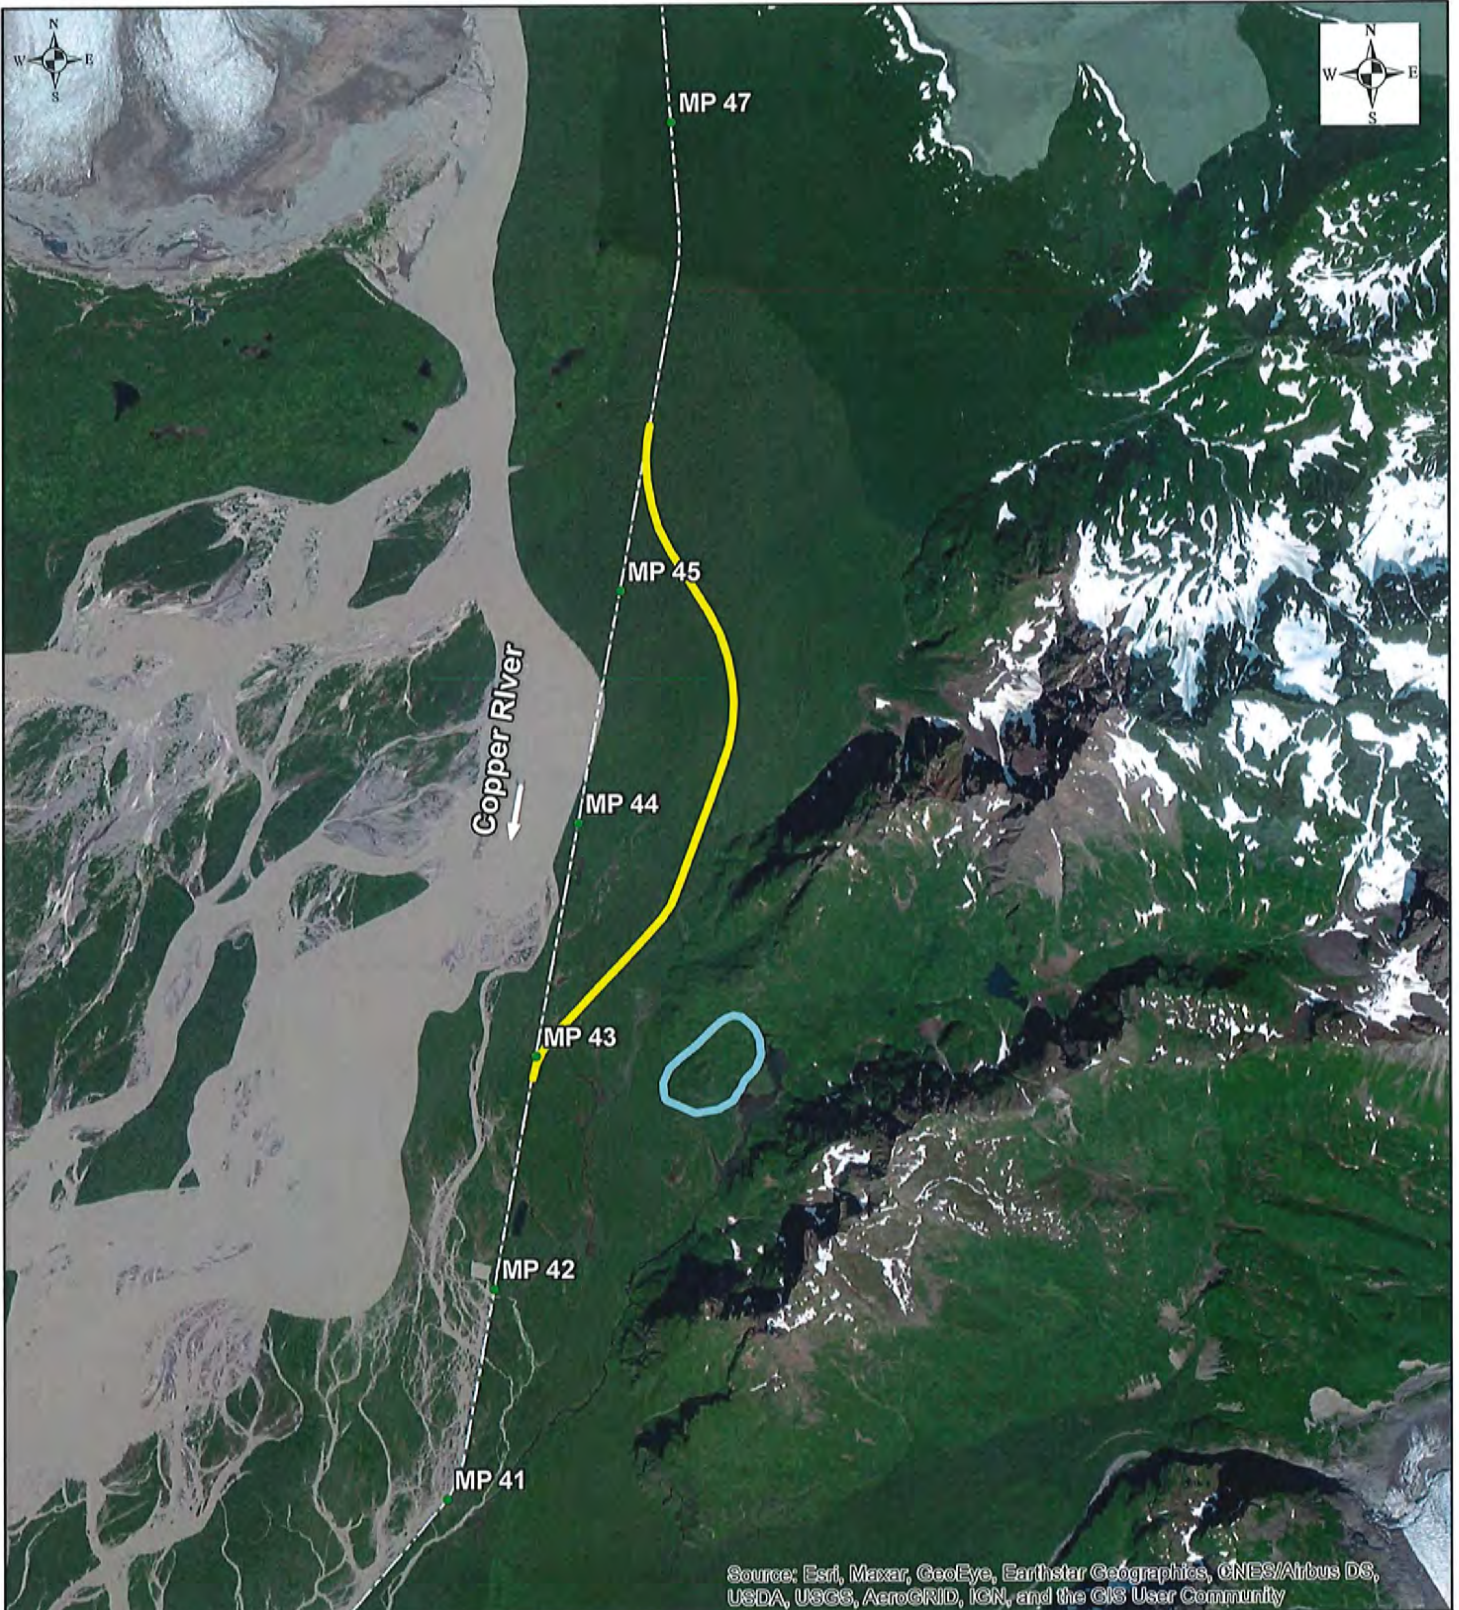
Figure 5: Location of Proposed Material Site at Toe of Goat Mountain's Glacial Valley

Through a review of the same LIDAR imagery, the DOT&PF identified an anomalous geomorphic feature at the toe of the glacial valley that cuts through Goat Mountain that warranted investigations into whether it's a viable material site. This glacial valley is also the headwaters of Clear Creek (AWC 212-20-1008-2010). The anomalous geomorphic feature is located within the SW 1/4 of Section 5, SE 1/4 of Section 6, NE 1/4 of Section 7, and NW 1/4 of Section 8; Township 15 South, Range 4 East, Copper River Meridian, USGS Quad map Cordova C-2. TEC owns the surface estate of this potential material site and Chugach Alaska Corporation owns the subsurface estate. The enclosed Figure 5 shows a plan view of this potential material site and its proximity to a proposed road alignment around the MP 44 washout.

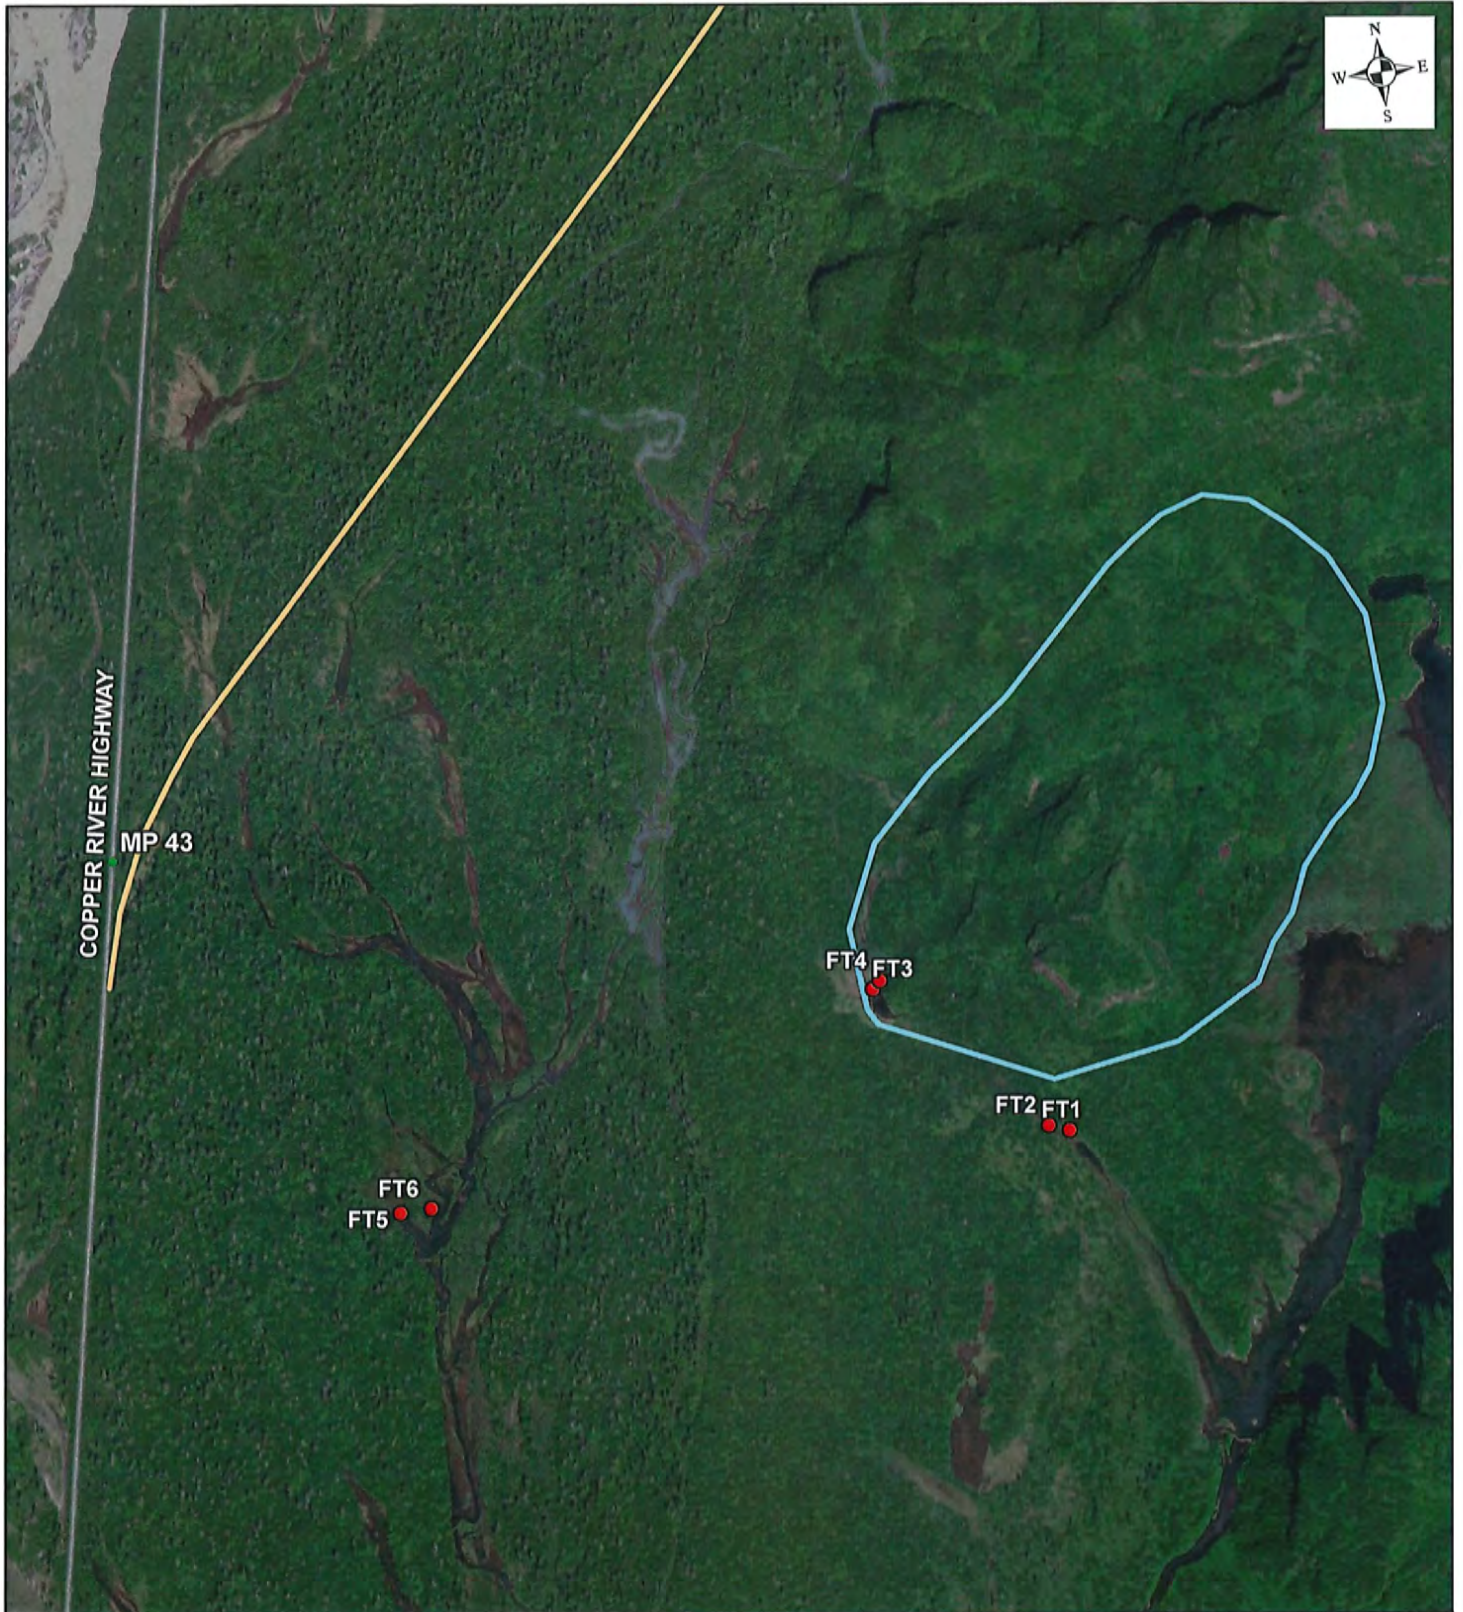
Figure 6: Fish Trap Locations

- Fish Trap Points
- Proposed Material Site
- Proposed Realignment

In order to ascertain whether fish are present, the hydraulics engineer installed fish traps in waterbodies near the west facing base of the material site, which are tributaries to Clear Creek. Fish traps were also installed in waterbodies located near the proposed new road alignment around the MP 44 washout and between the material site and the Copper River Highway, as a haul road would need to be constructed to access the material site. The enclosed Figure 6 depicts the location of the fish traps. The Copper River Highway PEL Fish Study is summarized below:

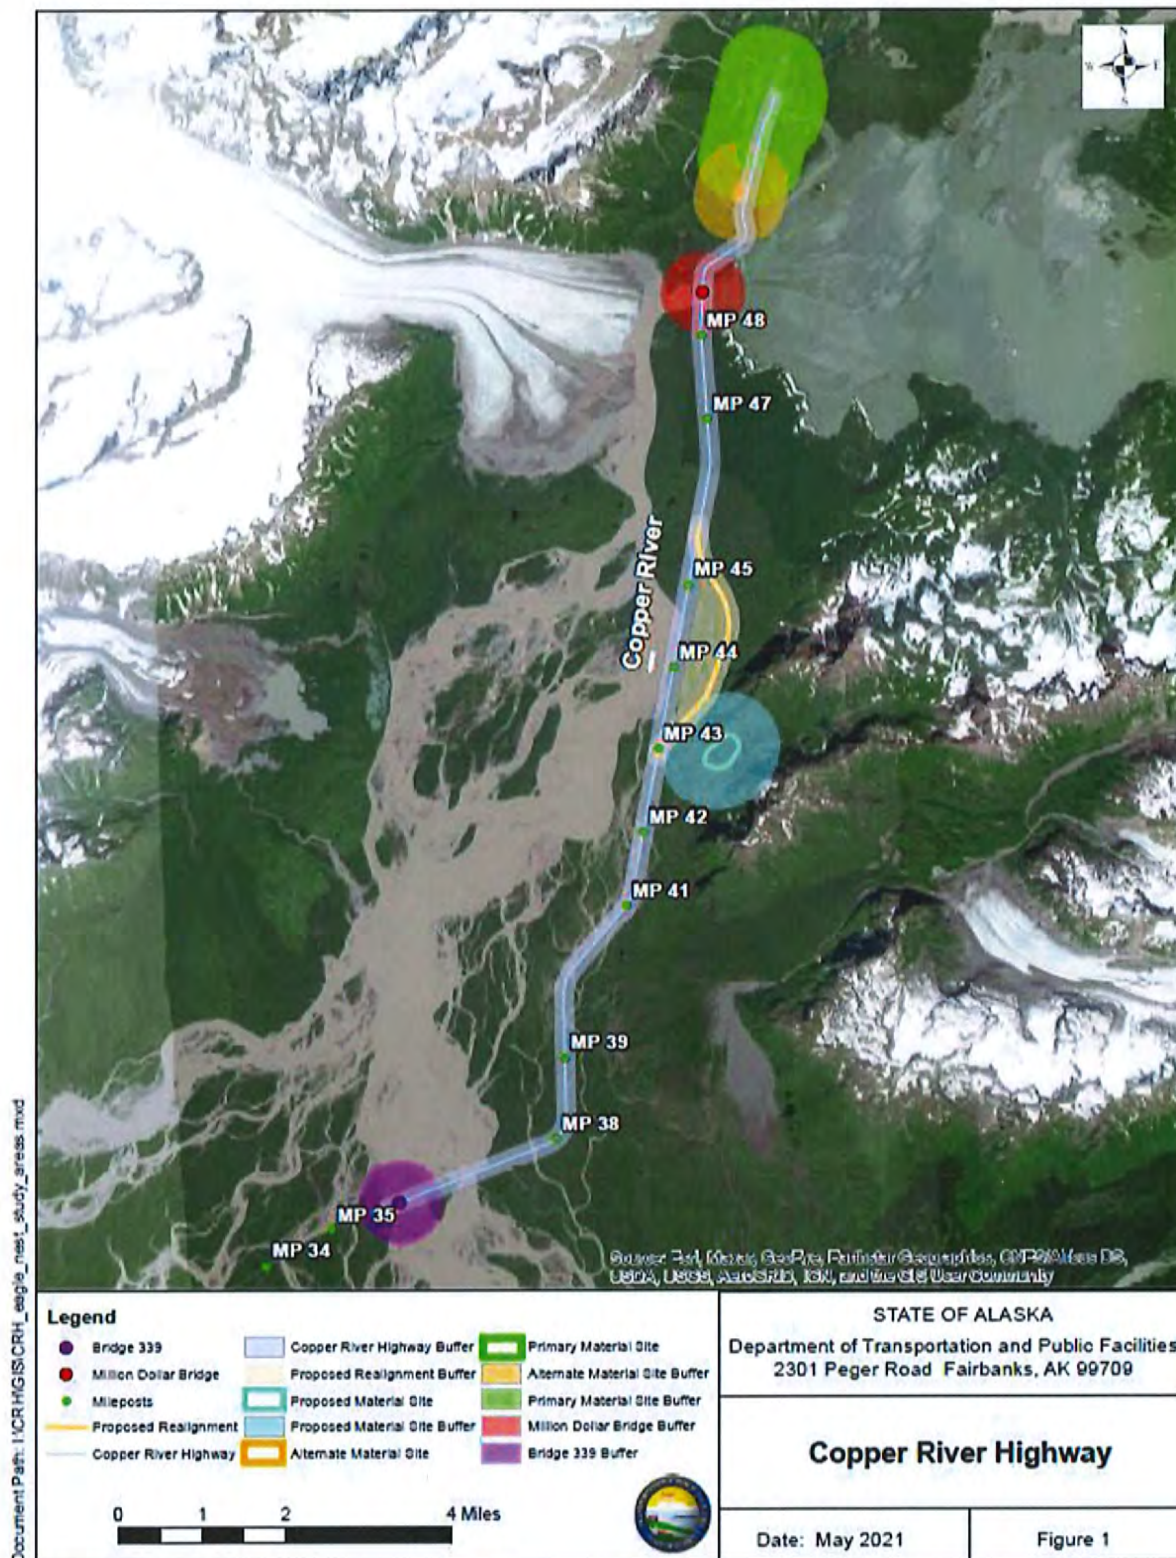
Figure 4: Copper River Highway with areas of interest identified.

Areas of interest were delineated by DOT&PF staff using GIS shapefiles (Figure 4). A survey grid of 1 km² units was superimposed over polygon features outside of the existing road corridor to standardize search intensity (Figure 5). Each unit of the survey grid was assigned a number for data recording purposes. Forty-three units were assigned but six were eliminated because they did not overlap with any polygon features. Therefore, 37 units were identified for survey.
